BANK EROSION STUDY

Ohio River Division Field
OHIO RIVER BANK
EROSION STUDY.

OHIO RIVER
BANK EROSION STUDY

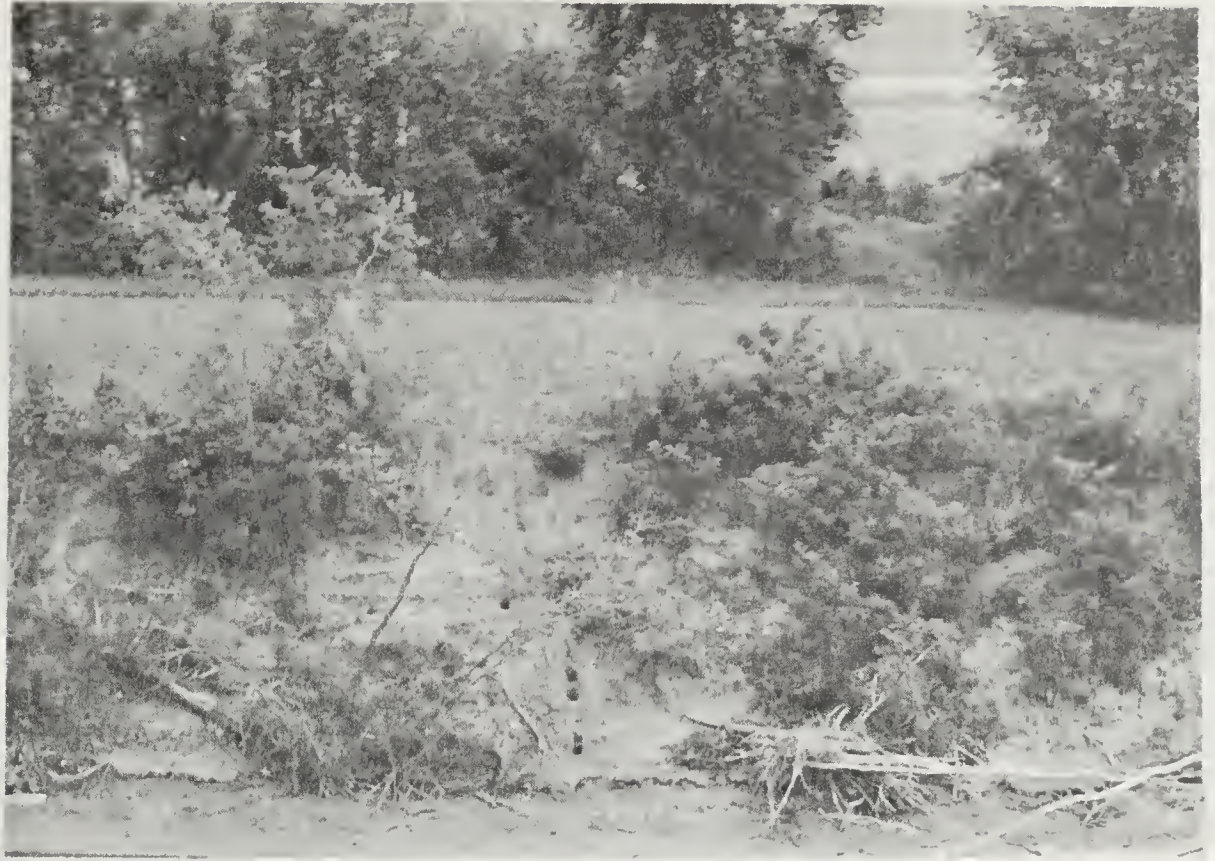
C

Bank area approximate to upstream boundary of tract
at sample site. 24 May 1977

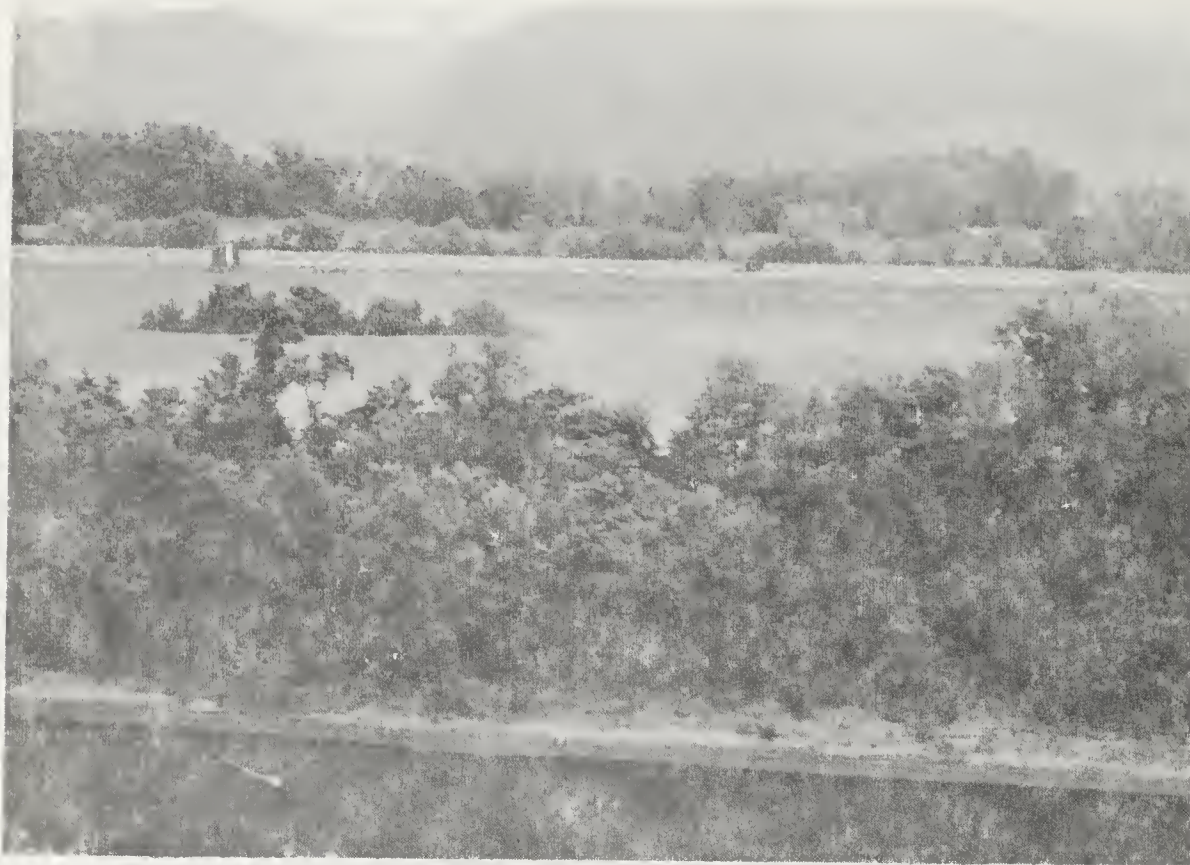
A

Reach of bank and sample site. 24 May 1977

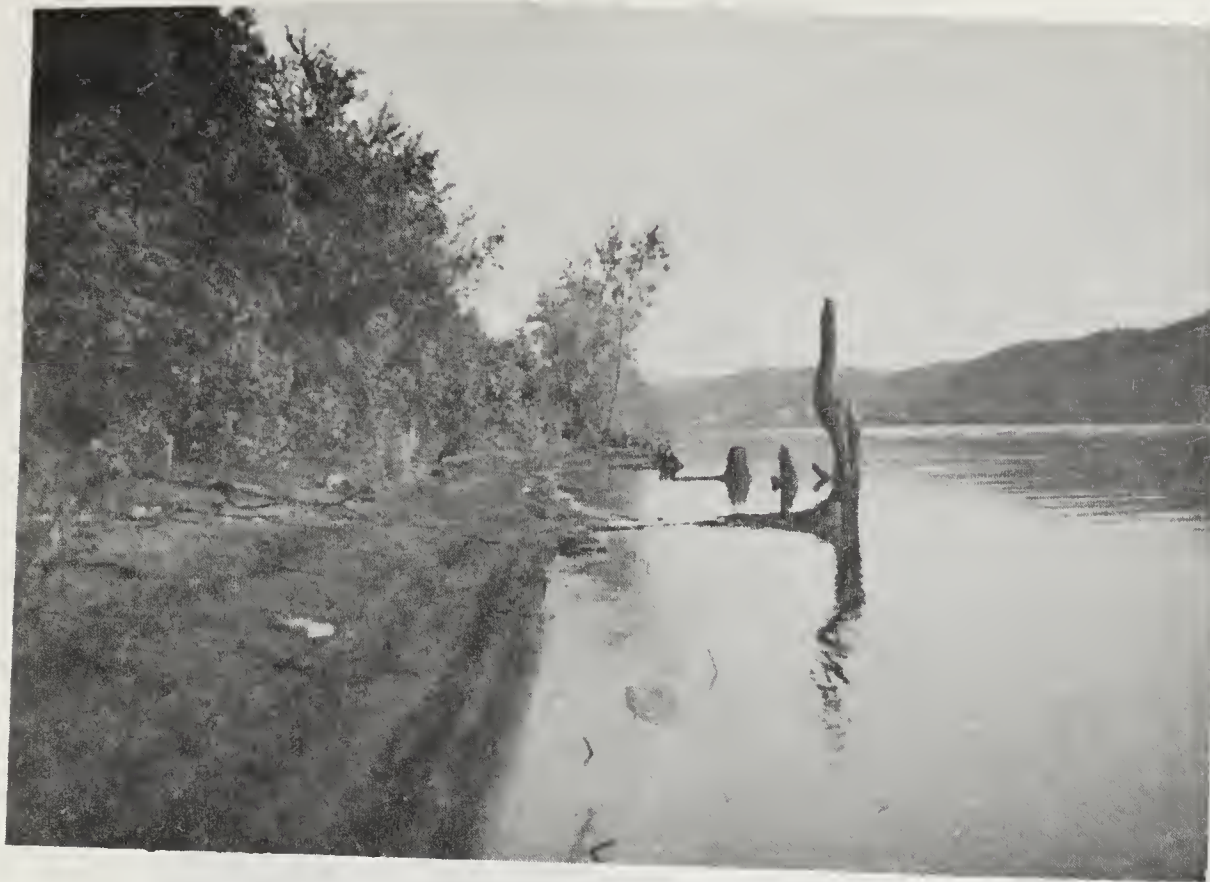
C

Reach of lower bank and slope looking upstream
toward limit of tract. 12 May 1977

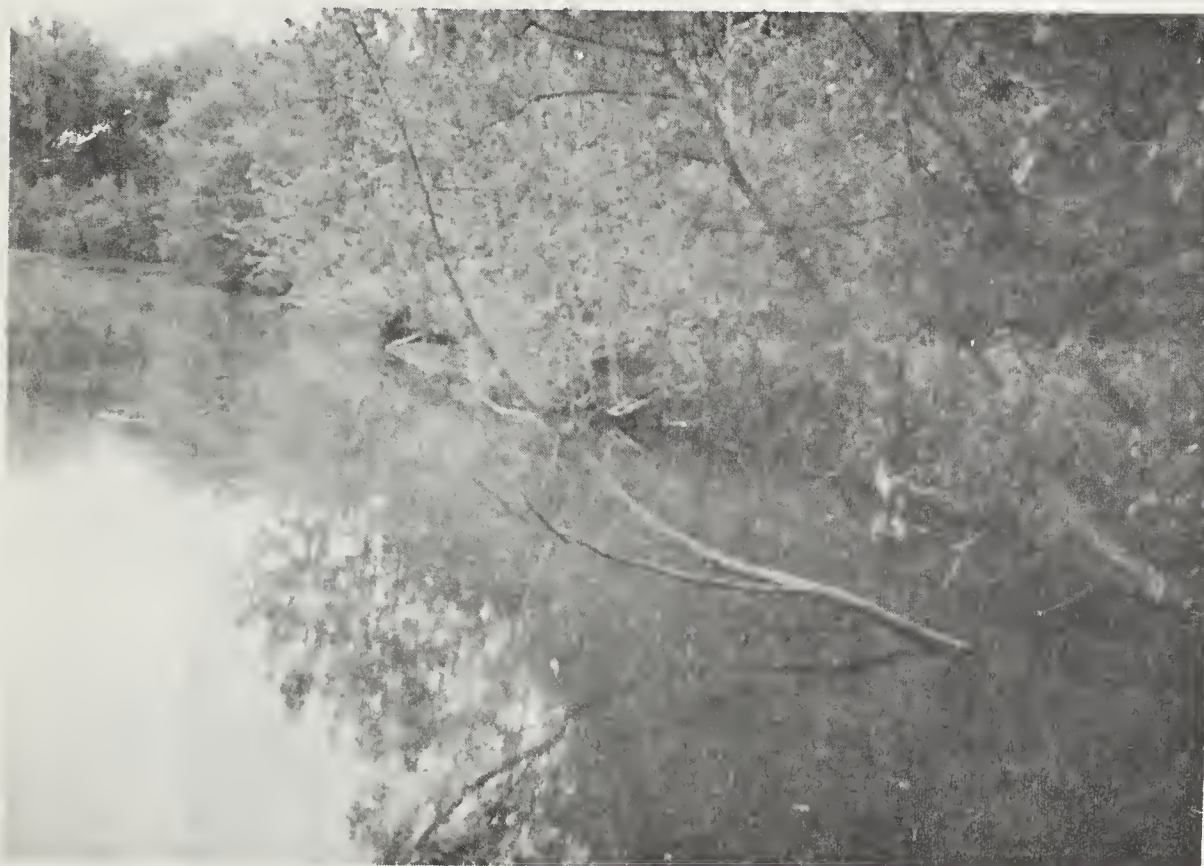
D

Reach of lower slope on tract along Three Mile
Creek Ohio. 12 May 1977

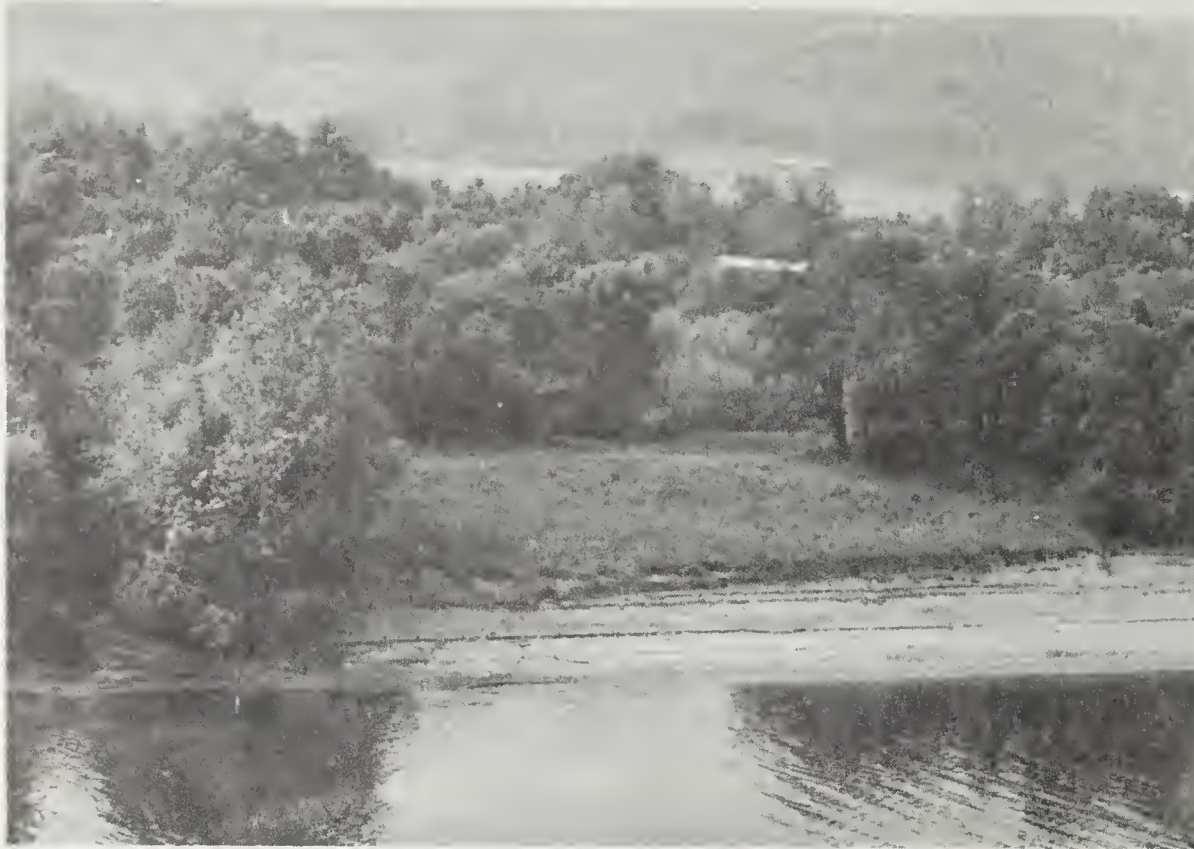
A

Reach of slope approximate to upstream limit of tract.
Note low terrace in tributary valley. Tributary stream
at far left. 24 May 1977

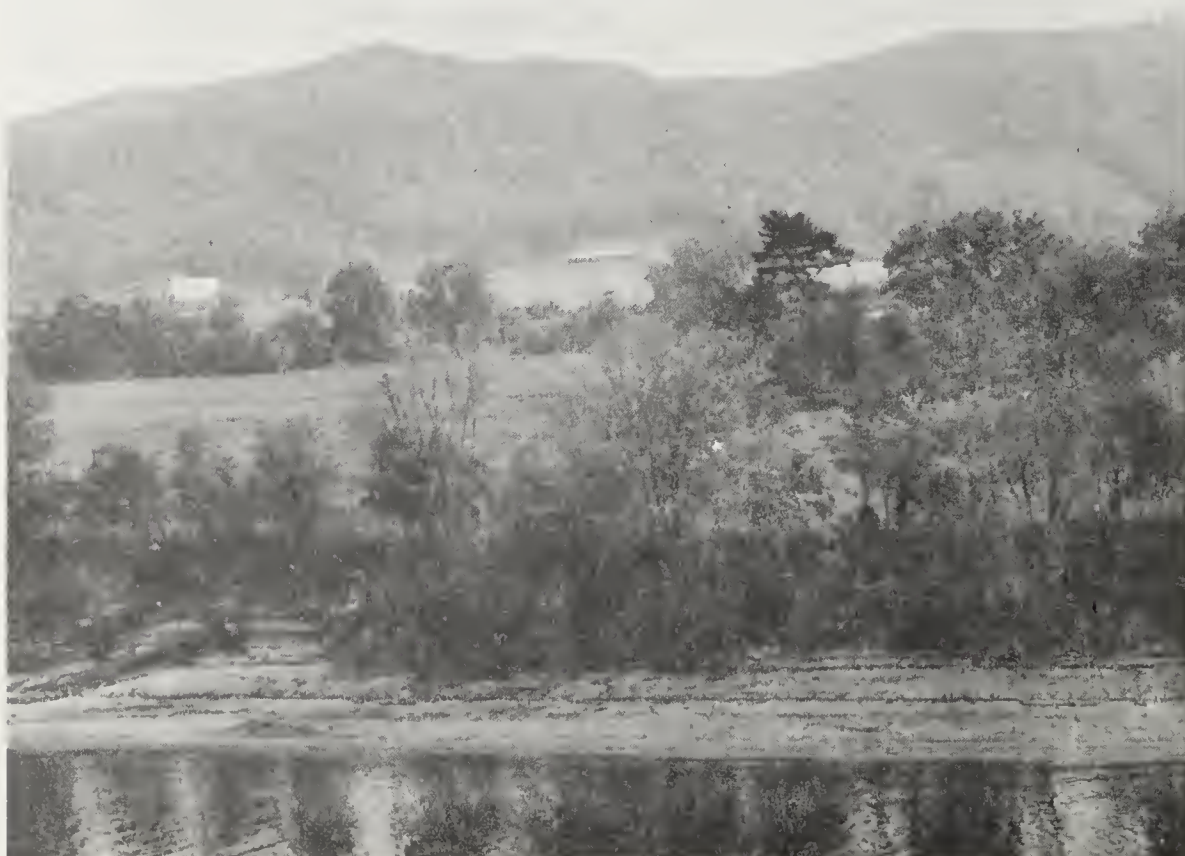
B

Vicinity of sampling site in central portion of
property. Only high terrace present.
24 May 1977

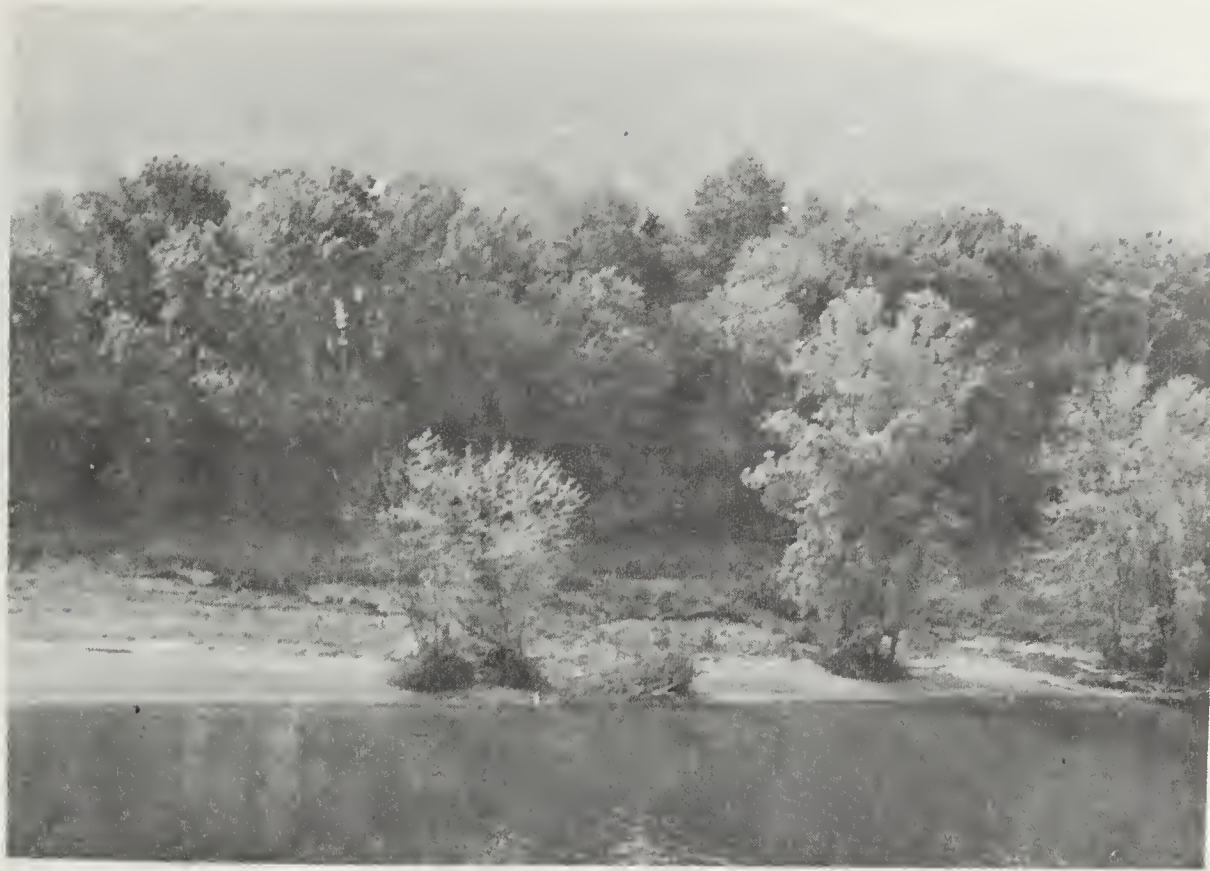
C

Downstream limit of property showing lower terrace.
High terrace located behind tree line.

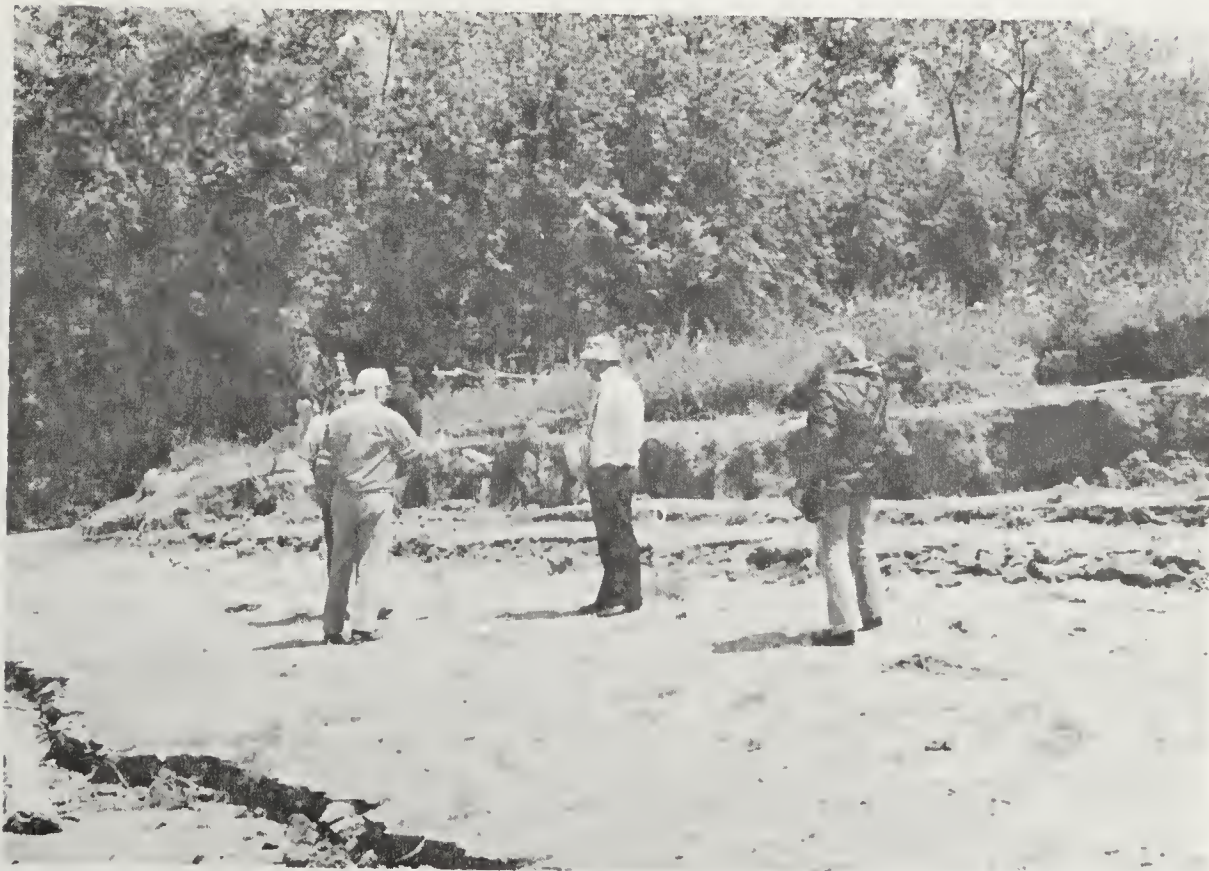
D

Looking upstream near limit of tract.
Unnamed tributary enters Ohio River at left.
10 May 1977

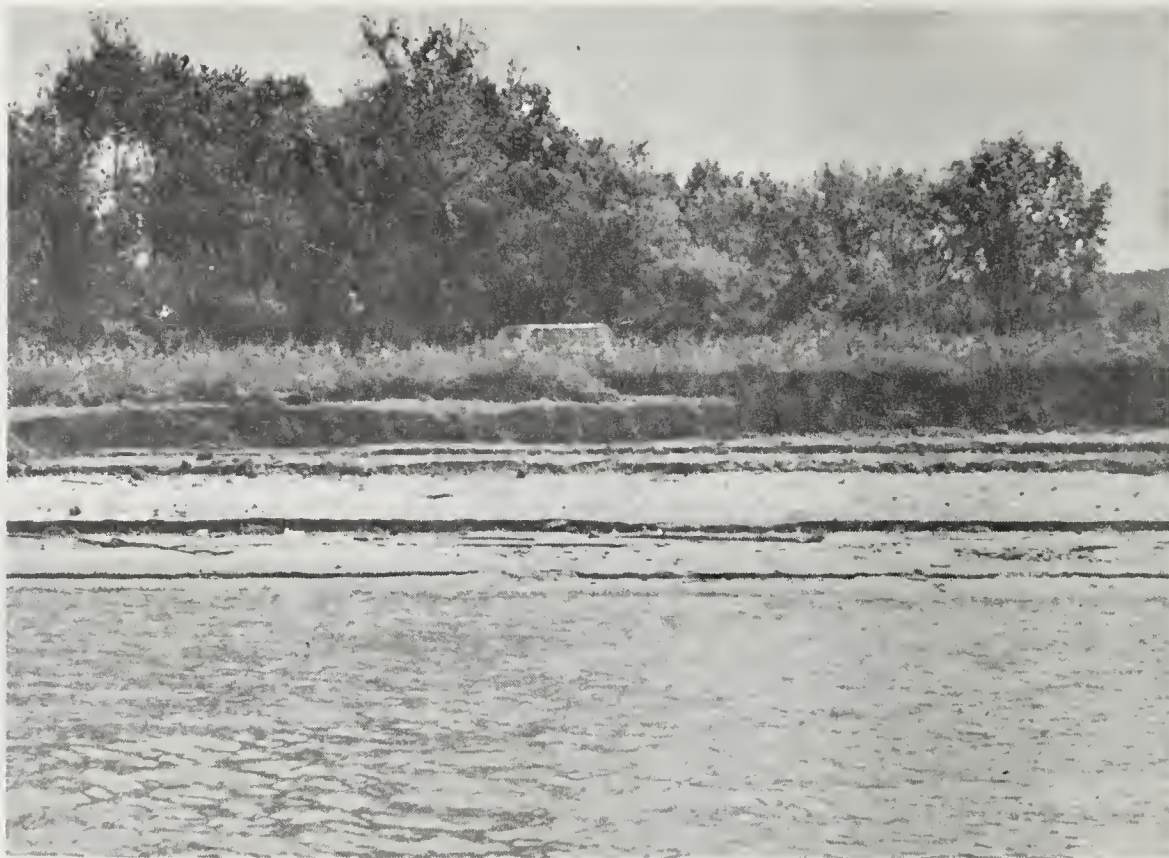
E

Lower terrace near upstream limit of tract.
10 May 1977

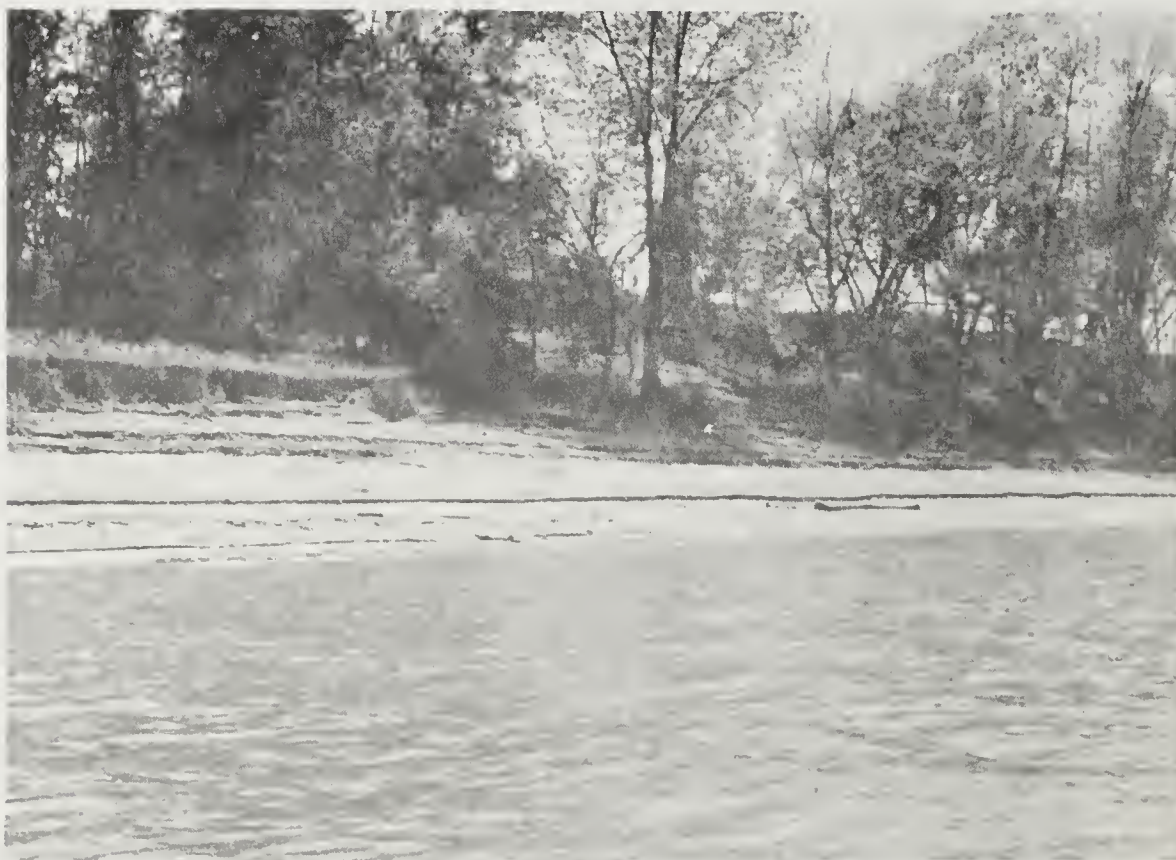
F

Beginning of high terrace frontage along Ohio
River at right. Downstream **limit of lower terrace**
at left. 10 May 1977

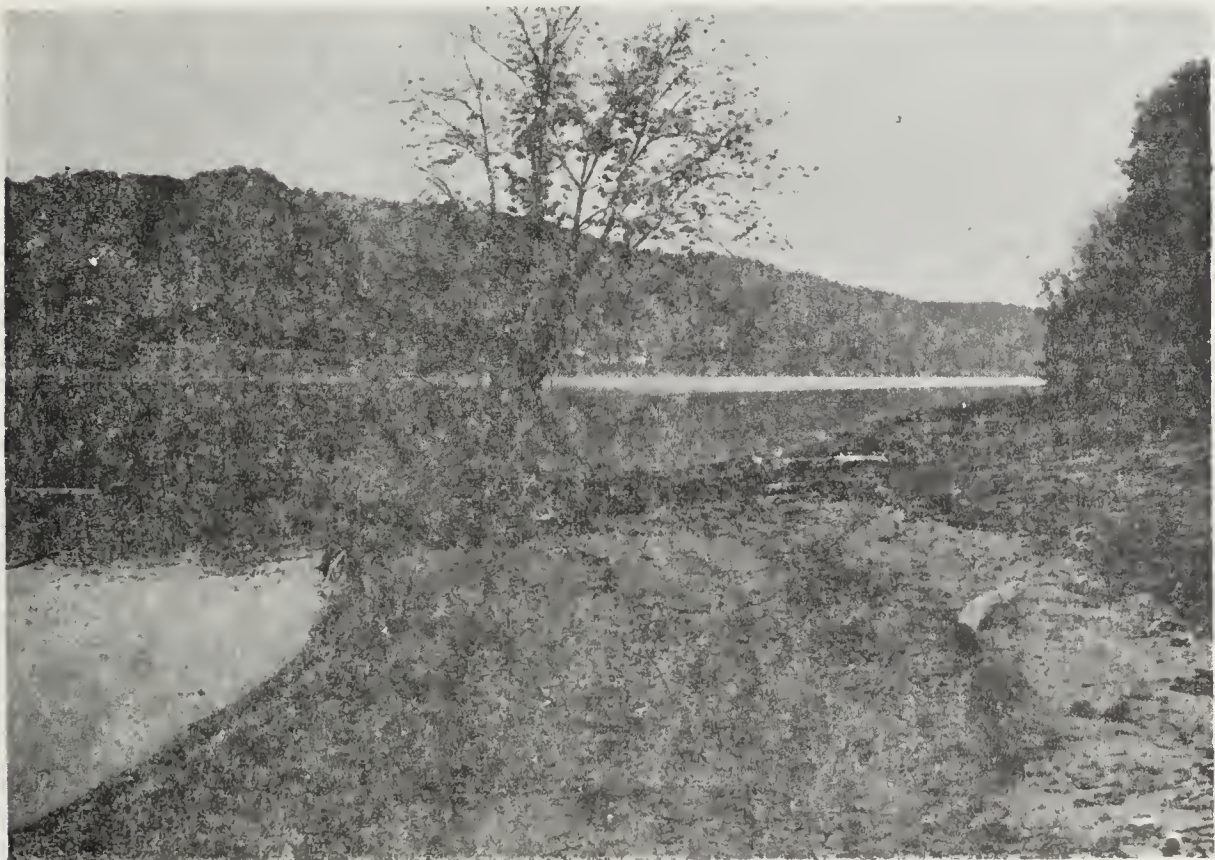
H

Looking upstream from near downstream limit of tract. 12 May 1977

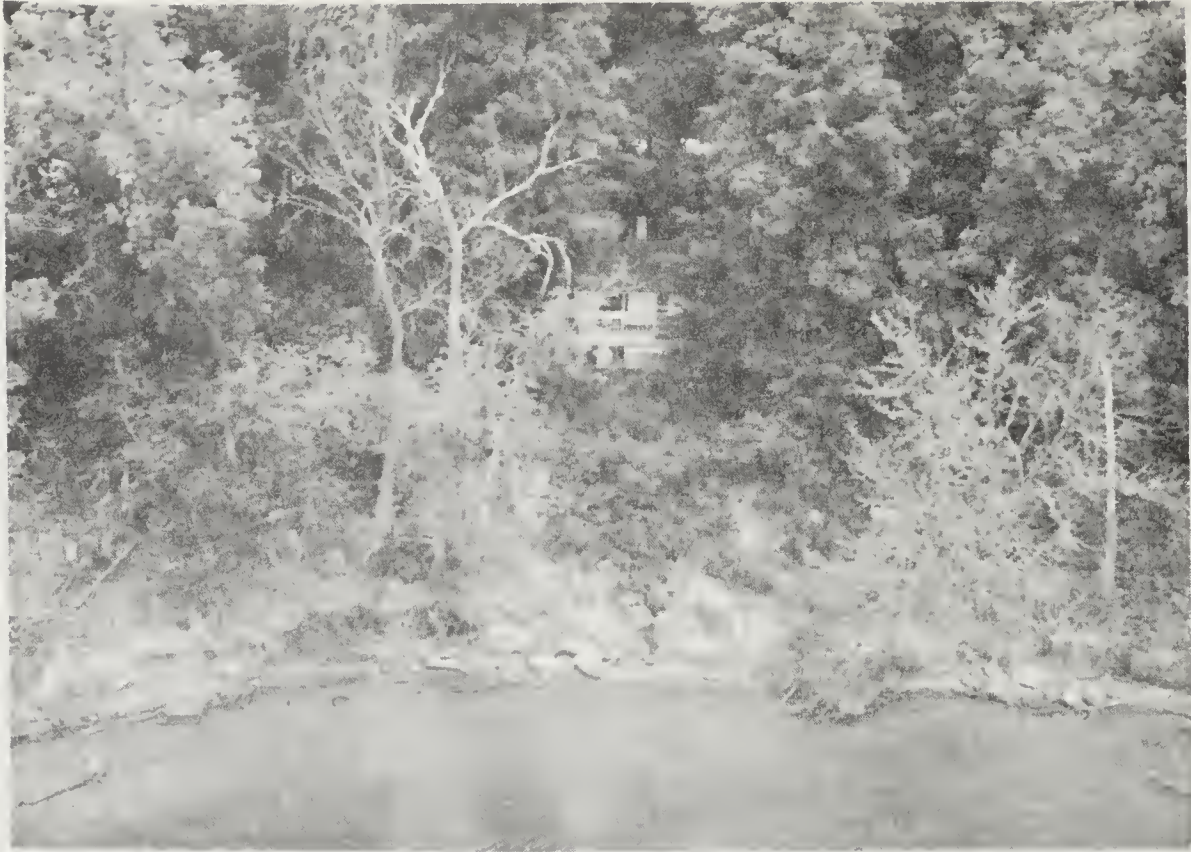
A

Slide area and structure. 23 May 1977

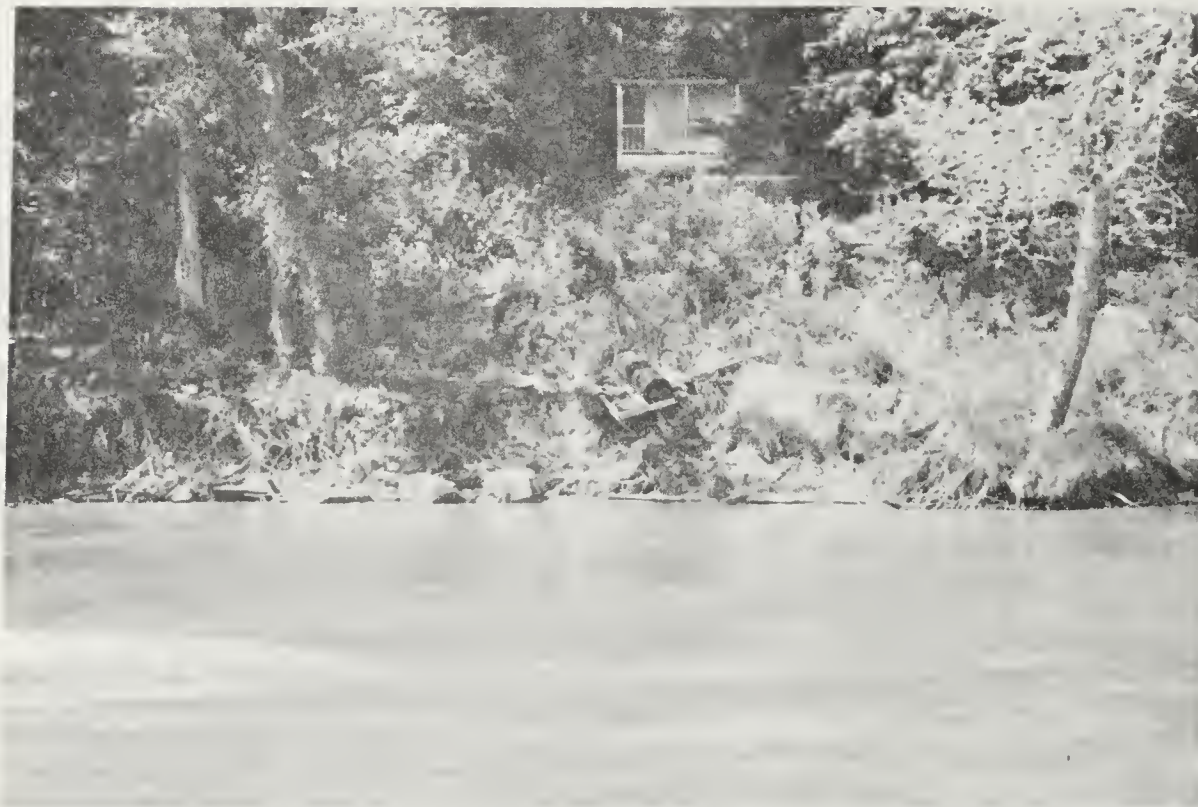
B

Toe of slide and sample site. 9 May 1977

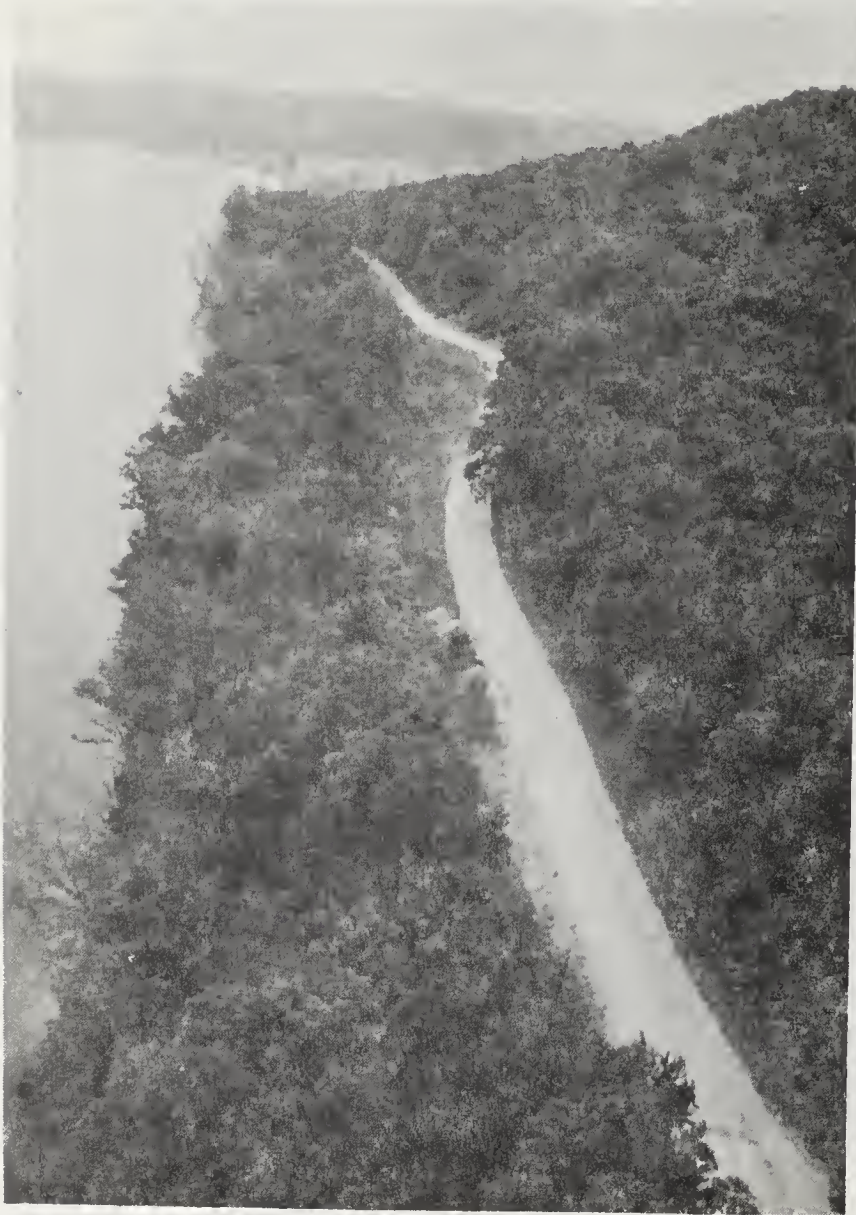
A

Looking downstream from the Bynon property
along Rt. 166 alignment. Note bend in
road at landslide area. 23 May 1977

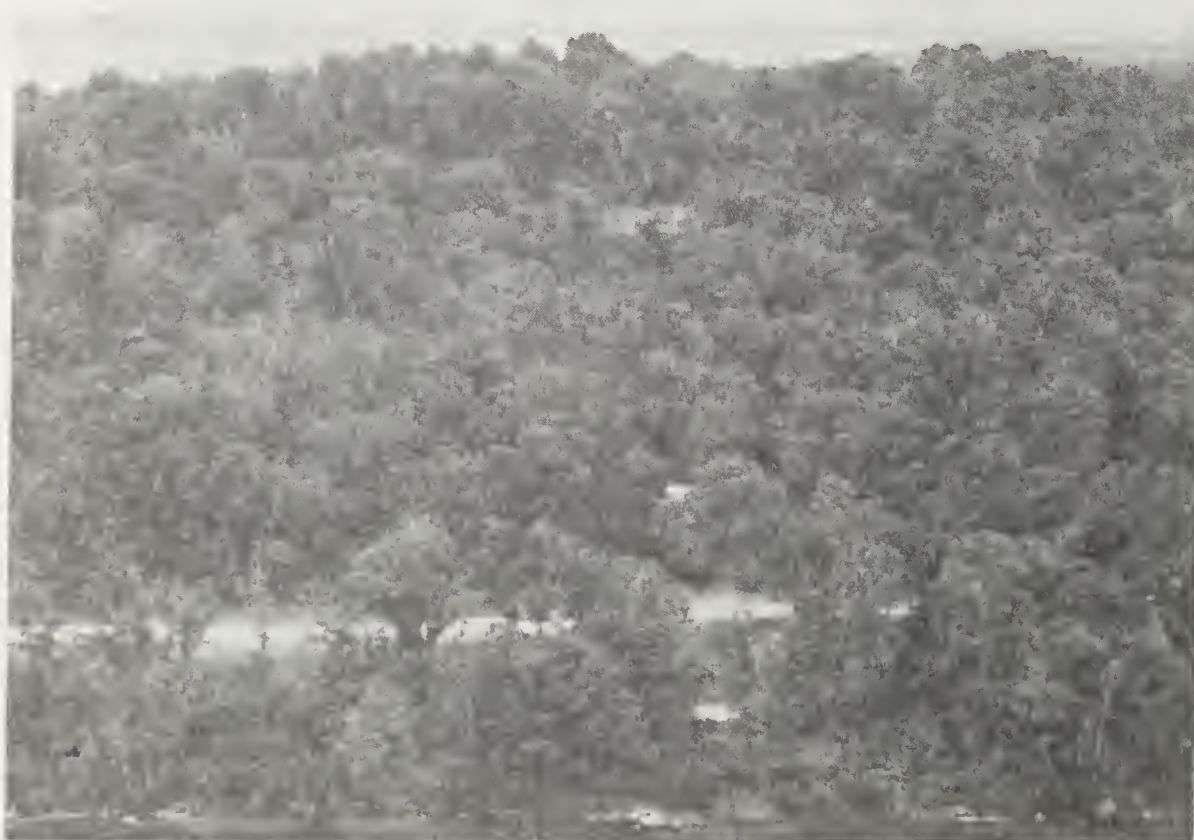
B

Looking at the Bynon property. Note rock out
crop and landslide area with fallen trees at lower left
of cliff. 23 May 1977

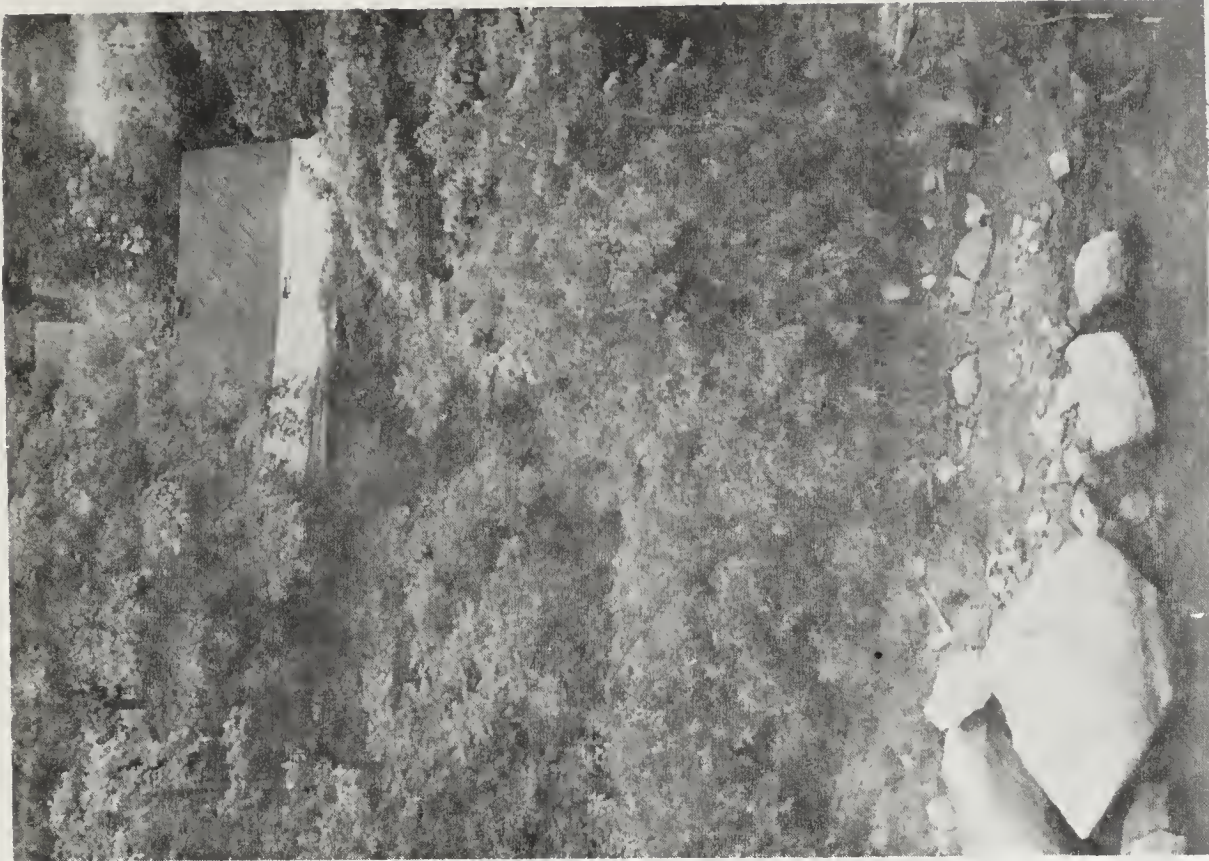
C

Slide area and structure. 5 May 1977

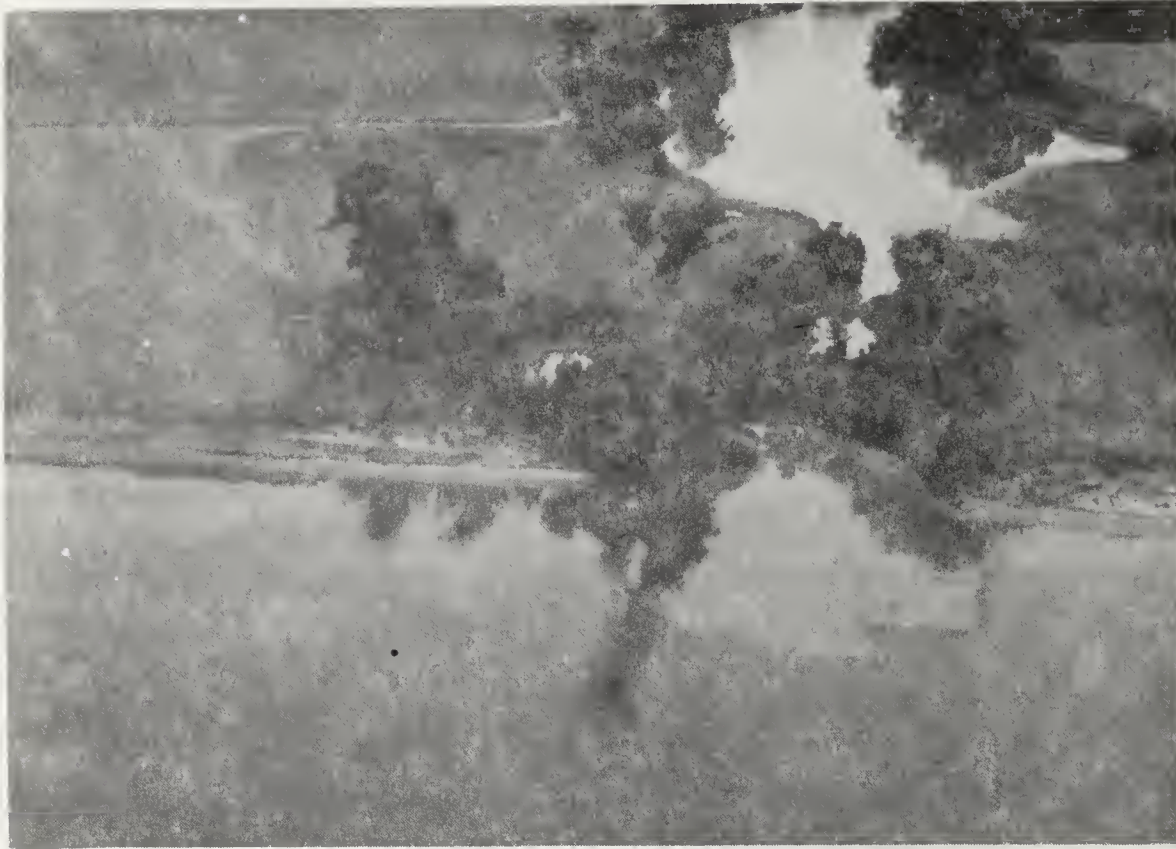
A

Confluence of Pond Run with the Ohio River. Note sediment plume. 23 May 1977

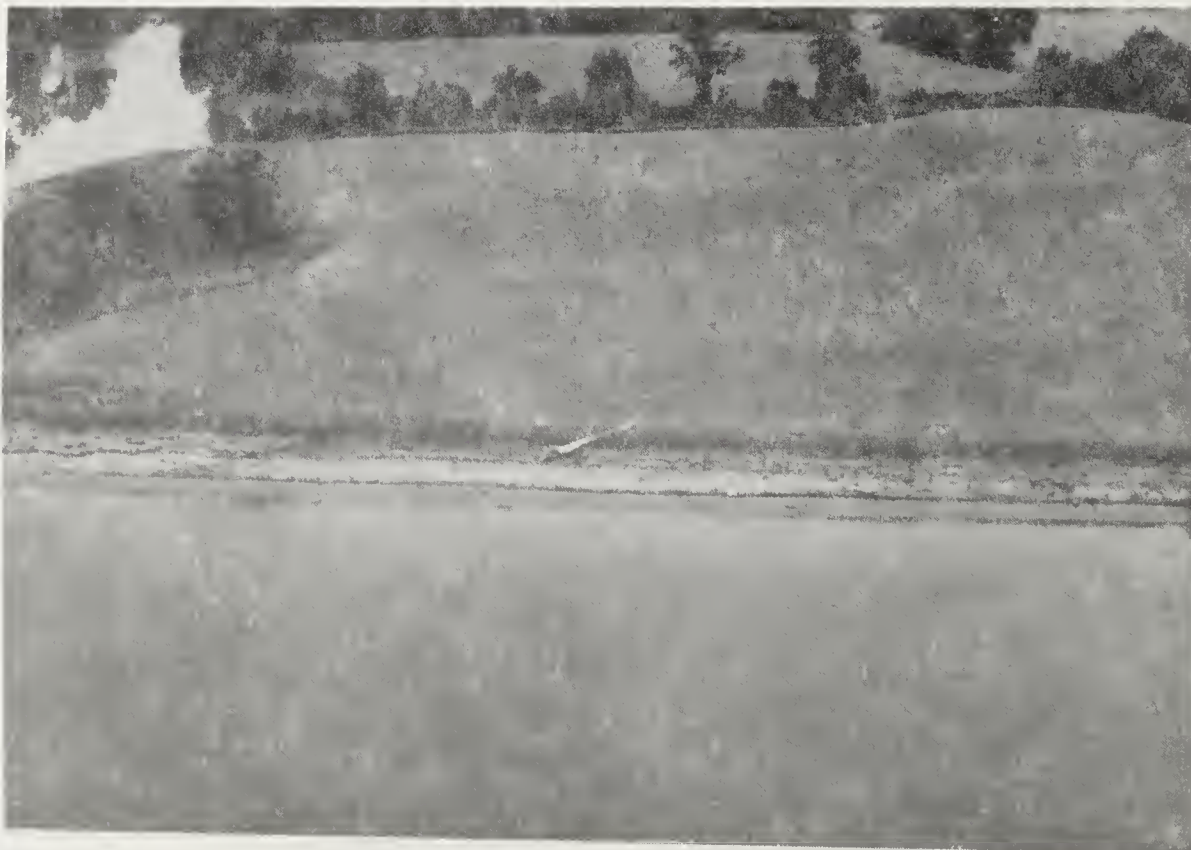
B

Bank area in central portion of tract. Pond Run located at left. 23 May 1977

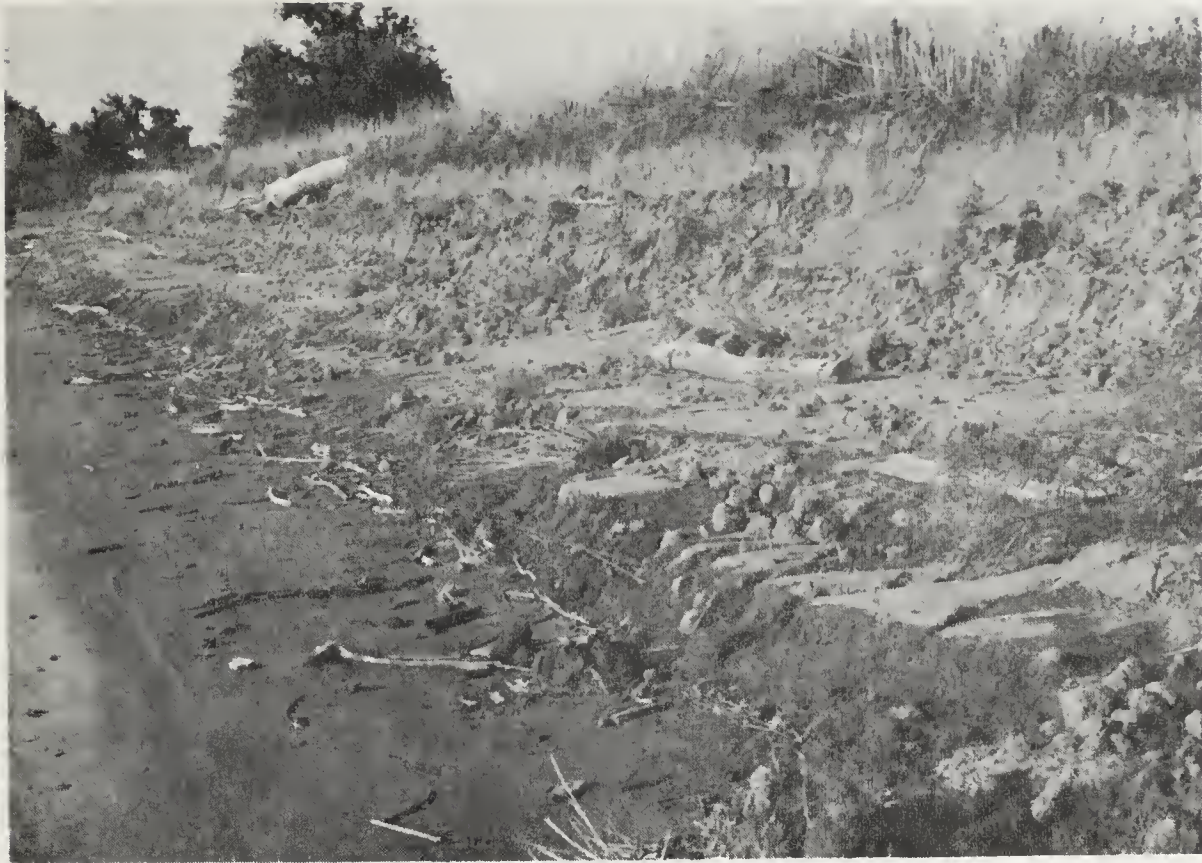
C

Face of bank looking downstream from approximate the
tract mid-point. 5 May 1977

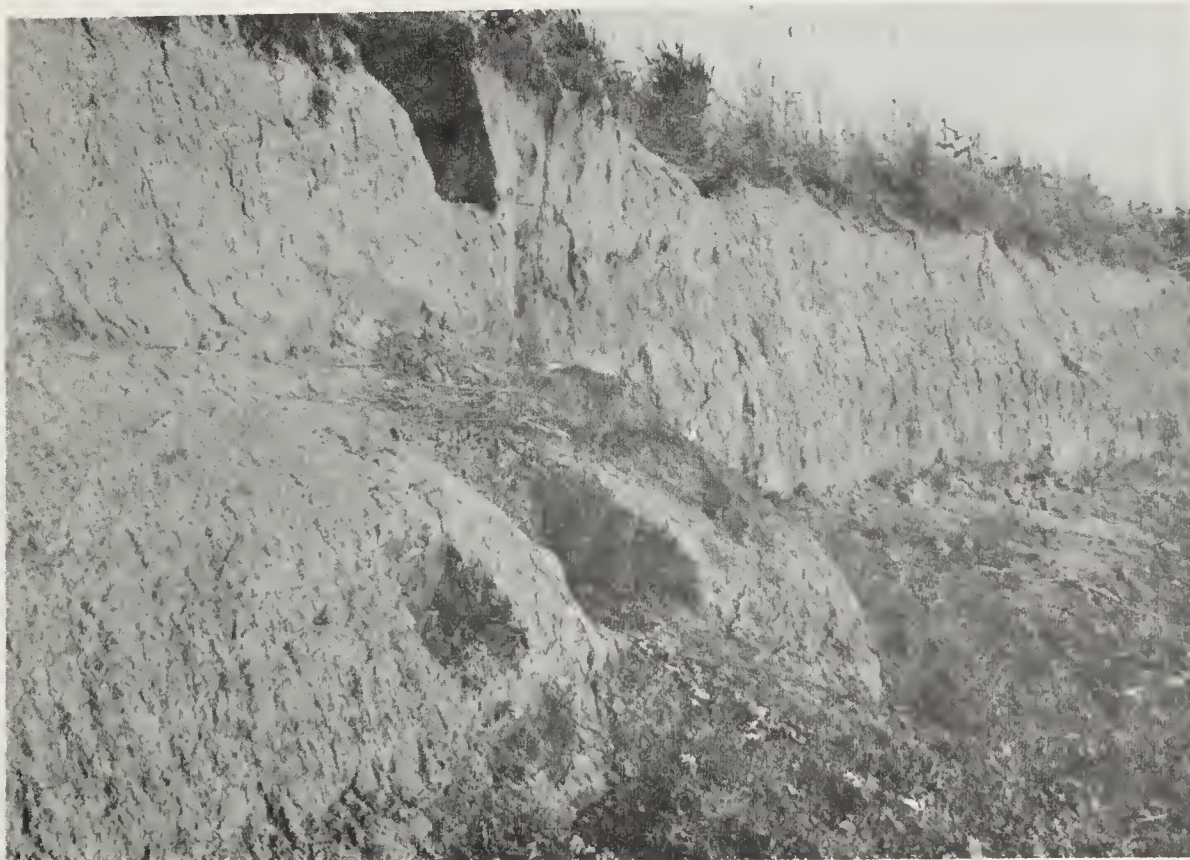
D

Sample site. 5 May 1977

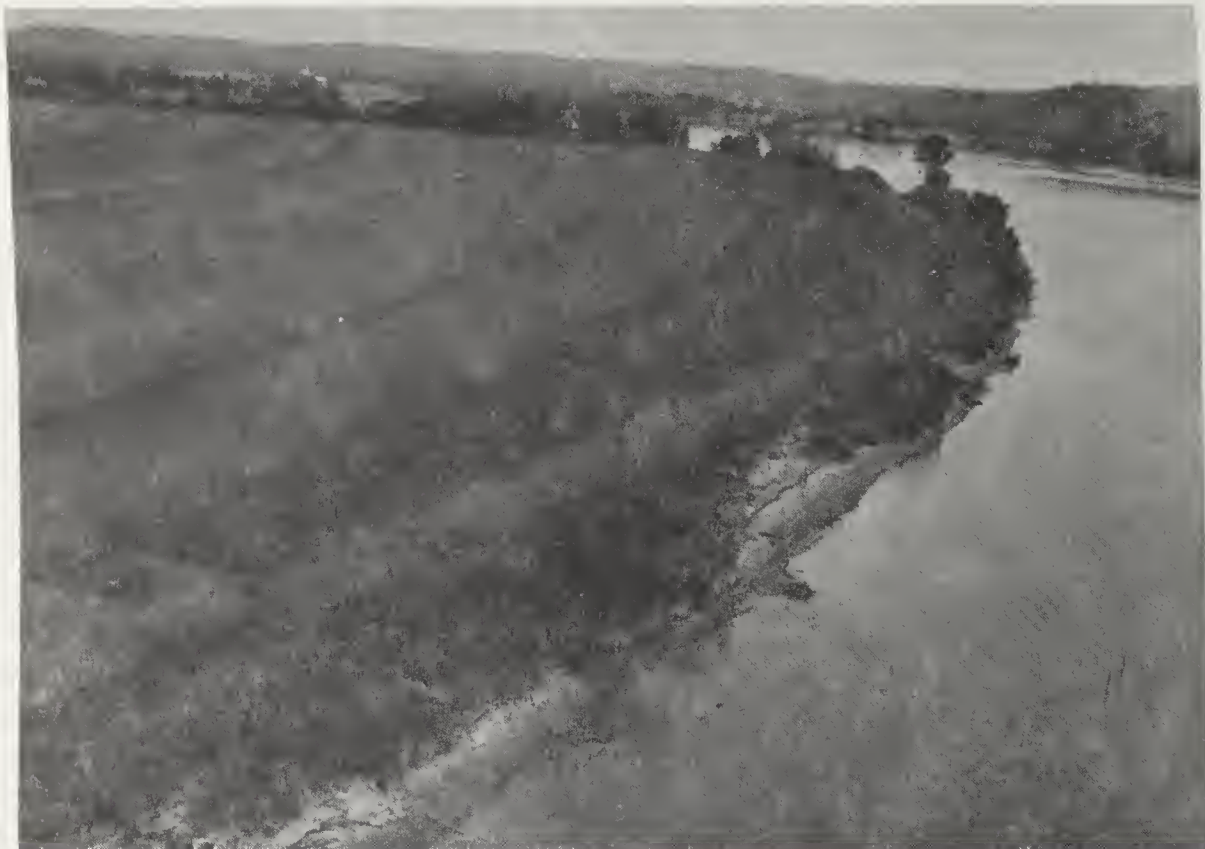
A

General view of Loesch property looking up river.
23 May 1977

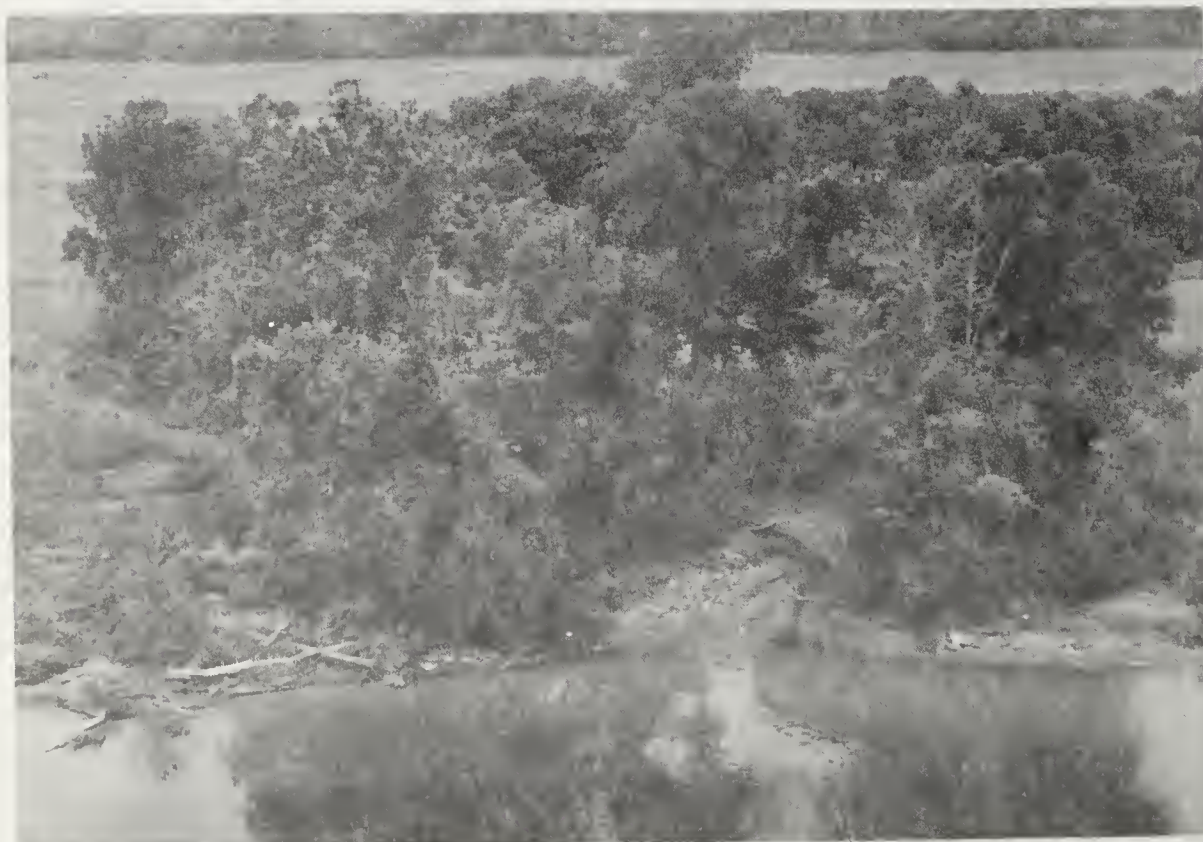
B

Aerial view of mouth of unnamed tributary near
upstream tract boundary. 23 May 1977
